Wall Inspection Report

Inspection Date: May 21, 2020

Prepared for: Development Services
City of Goodyear
14455 W. Van Buren Street, Suite D101
Goodyear, Arizona, 85338

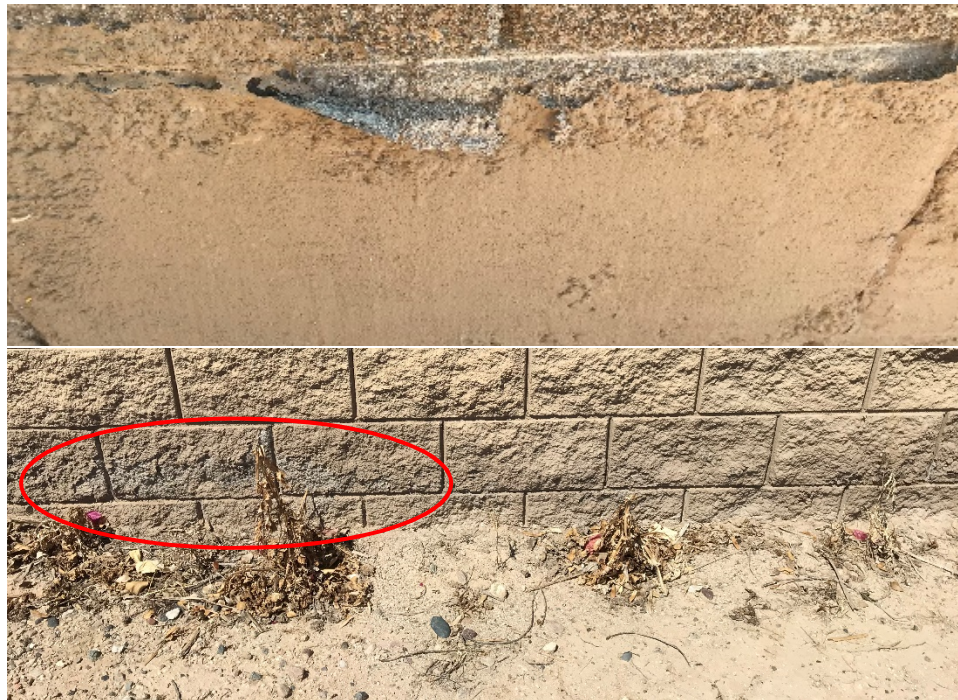
Figure 8. Examples of Loss of Paint and Surface Degradation

- **Loss of Paint and Surface Degradation** refers to paint loss and some surface degradation at the lower two rows of blocks. This condition is likely attributed to the presence of excess moisture in the blocks from external sources. Examples are shown in **Figure 8**.

The inspection of the privacy wall for 29 residential properties revealed that while the wall has a few minor issues such as surface degradation at the bottom of wall, slightly loose wall panels and CMU's, the wall is generally in good conditions. No severe cracking, settlement or tilting of the wall was observed. The predominant issue observed was the loss of paint and surface degradation of the bottom two rows of blocks for most of the wall. In order to prevent further degradation, it is advised to keep moisture from all external sources away from the wall and grade the ground behind and in front of wall to slope away from the wall.

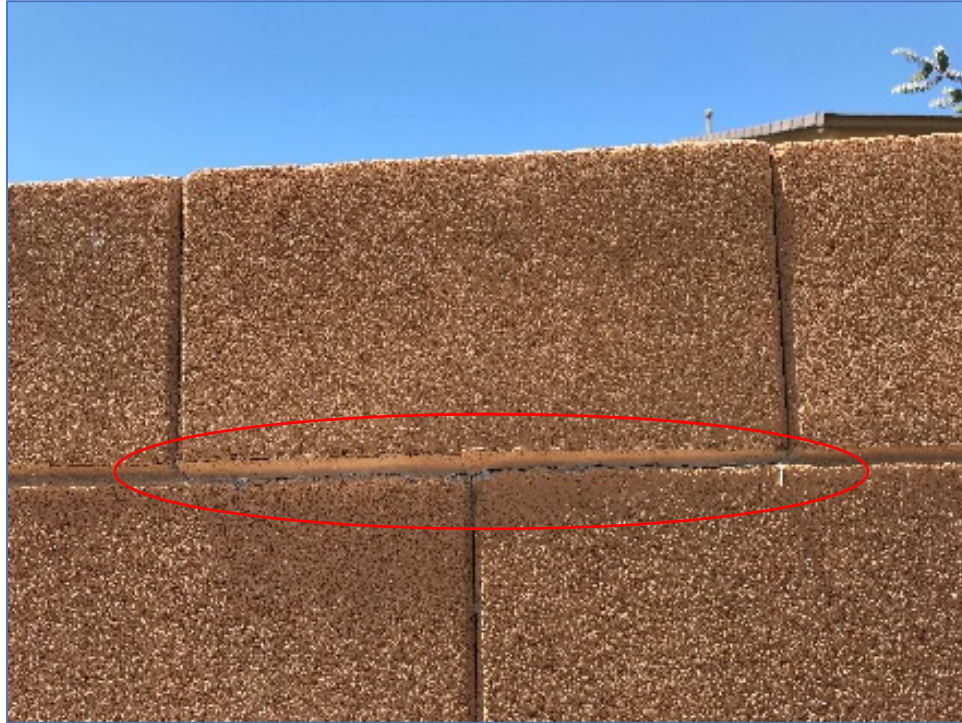
Figure 9. Example of Loose CMU

- **Slightly Loose Panels** describes panels that are slightly loose and would slightly wobble when pushed or shaken.
- **Loose CMU** describes blocks that are no longer bonded to the rest of the wall. This is due to the cracking or deterioration in the mortar between two rows of blocks. Example is in **Figure 9**

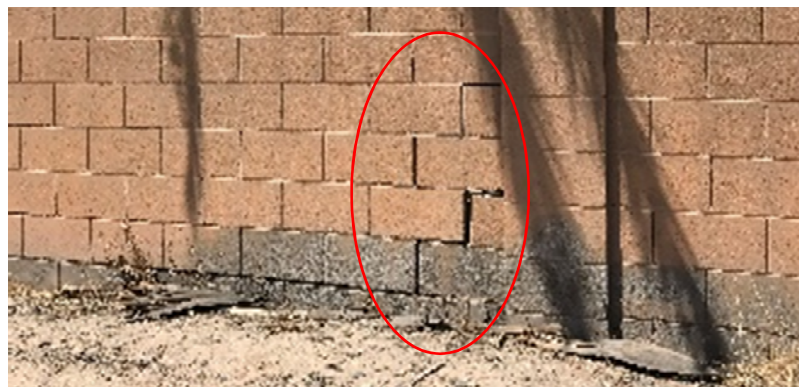
Figure 10. Examples of Cracking

- **Cracking** refers to the pattern of cracks along the mortar lines of the wall shown in **Figure 10**. They are typically found in a diagonal pattern (step crack) at the ends of the wall segments. Cracking can arise due to plant roots growth under the wall, upheaval, and differential settlement along the wall.

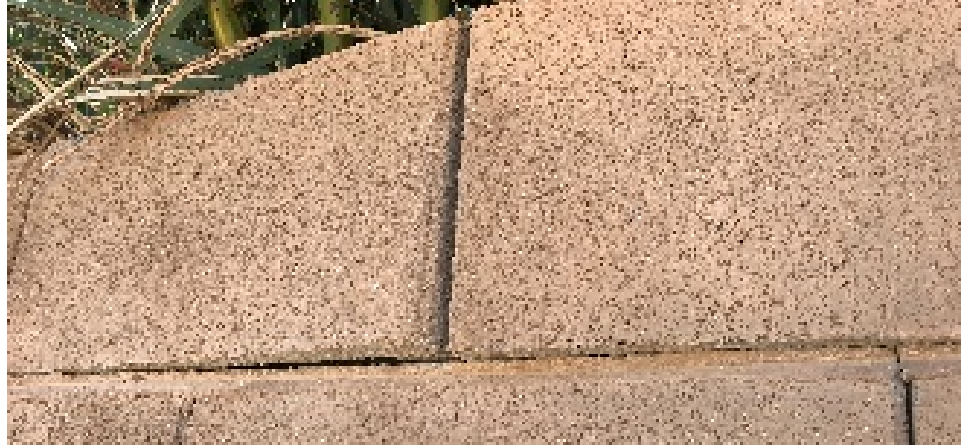
Figure 11. Examples of Bulging Blocks

- **Bulging Bricks** refers to a point in the wall where the bricks have been pushed out of position shown in **Figure 11**. This occurred at locations in the wall which had thick trees or plants growing near the wall. The growth from the plant would push out the bricks over time.

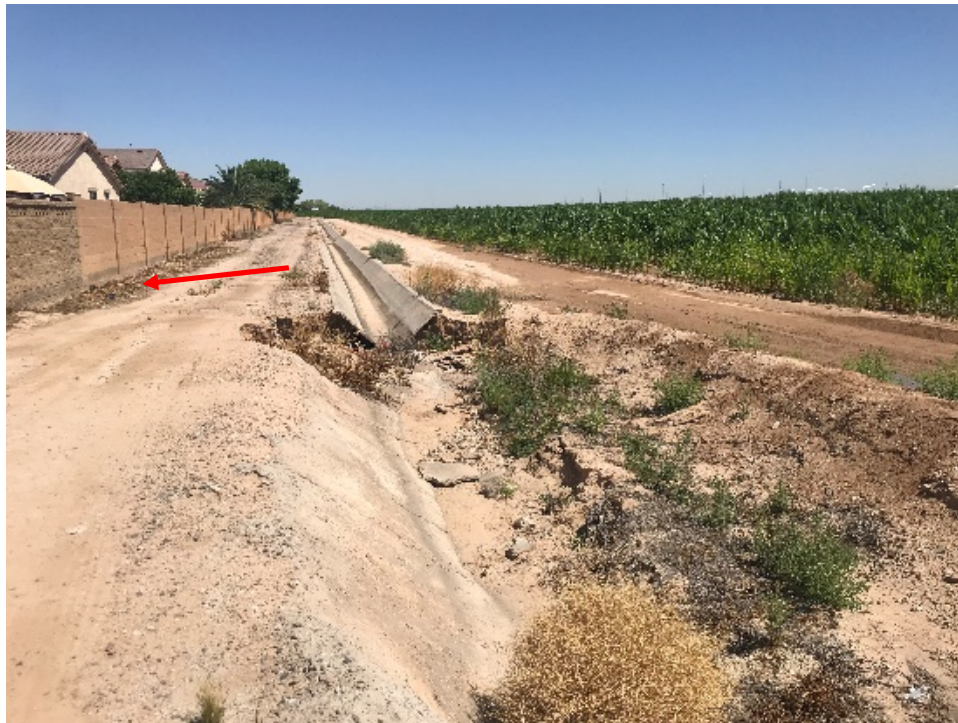
Figure 12. Ground sloping towards wall - Wall at South End

It is important to note that over the entire length of the wall the ground immediately behind the wall as shown in **Figure 12**, is sloping towards the wall. This may lead to water collecting near the bottom of the wall.

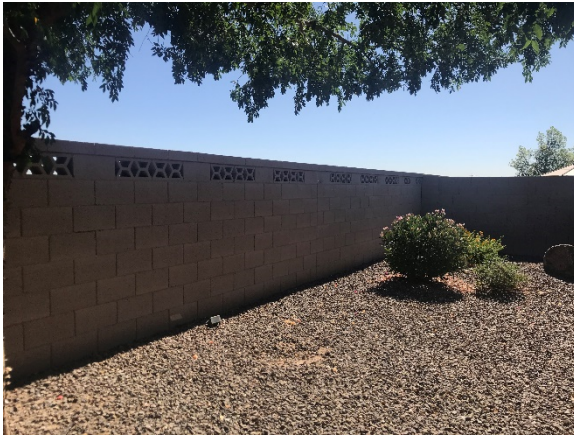
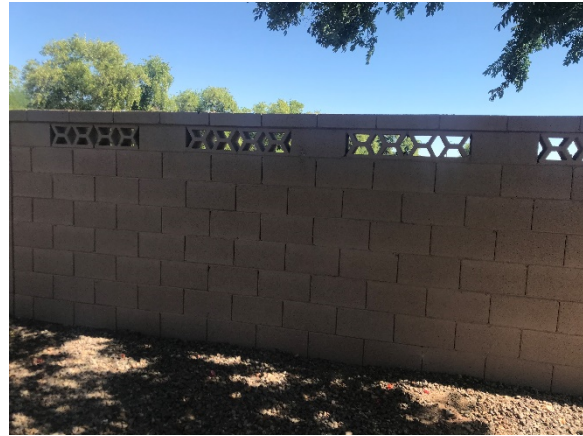
Figure 13. House No. 119 Wall Inspection

House No. 119. The property owner indicated that she would like the wall inspected to make sure it was in good condition. Upon inspection, no signs of damage, deterioration or defects were observed. **Figure 13** shows photographs of the interior side of wall.

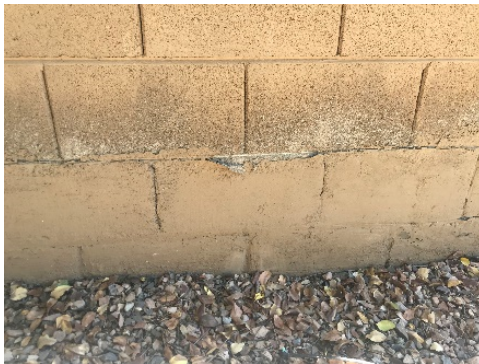
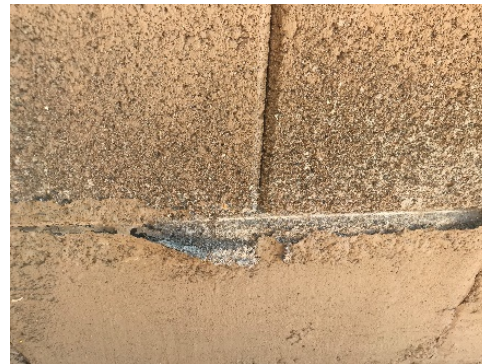
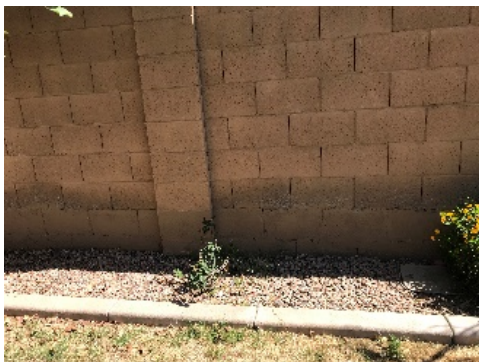
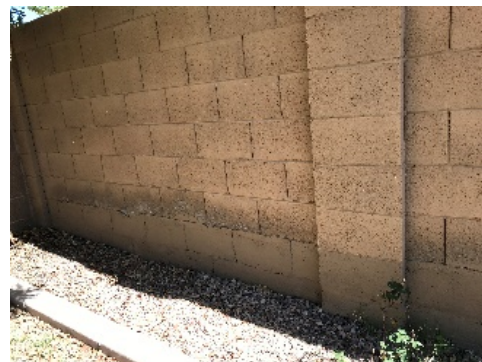
Figure 14. House No. 223 Wall Inspection

House No. 223. The issues observed along the wall are: The lower two rows of blocks exhibit paint loss and some surface degradation to a depth of approximately 1/16" almost for the entire length of the wall. It was also observed that top row of CMU's is loose along the entire length of the wall. **Figure 14** shows photographs of the interior side of wall.

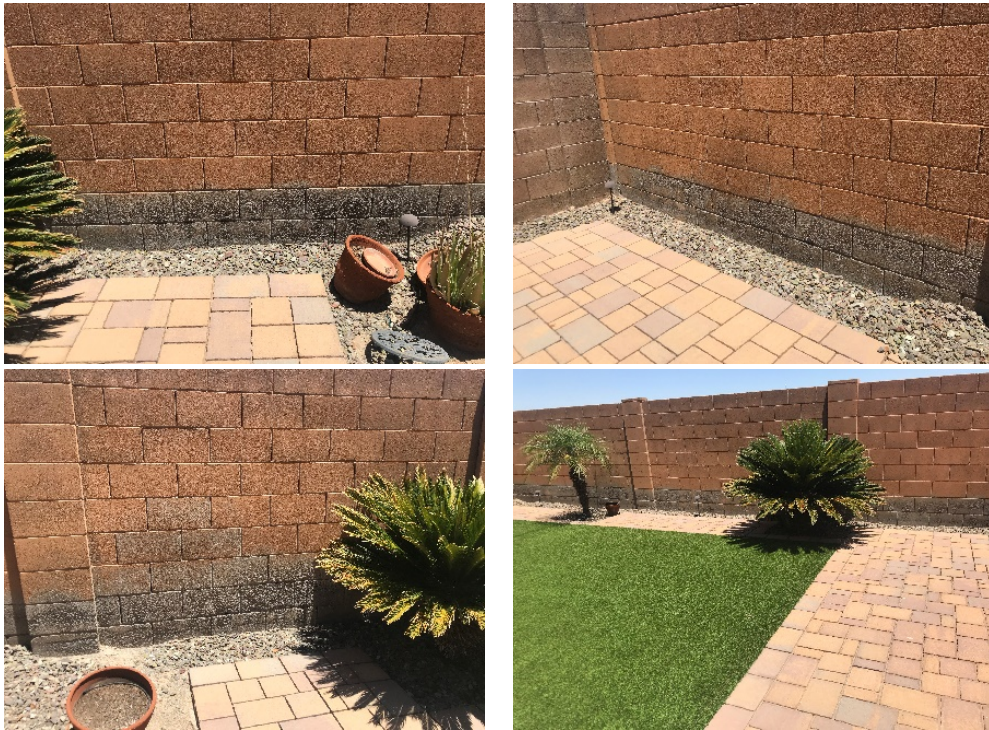
Figure 15. House No. 271 Wall Inspection

House No. 271. The lower two rows of blocks exhibit paint loss and surface degradation to a depth of approximately 1/16". There are also four wall panels that are slightly loose at one end and would wobble if pushed. **Figure 15** shows photographs of the interior side of wall.
