**CITY OF GOODYEAR  
PUBLIC WORKS DEPARTMENT  
WATER AND WASTEWATER FACILITIES CONDITION  
ASSESSMENT**

**PHASE 1 SUMMARY REPORT**

**FINAL**  
May 2015

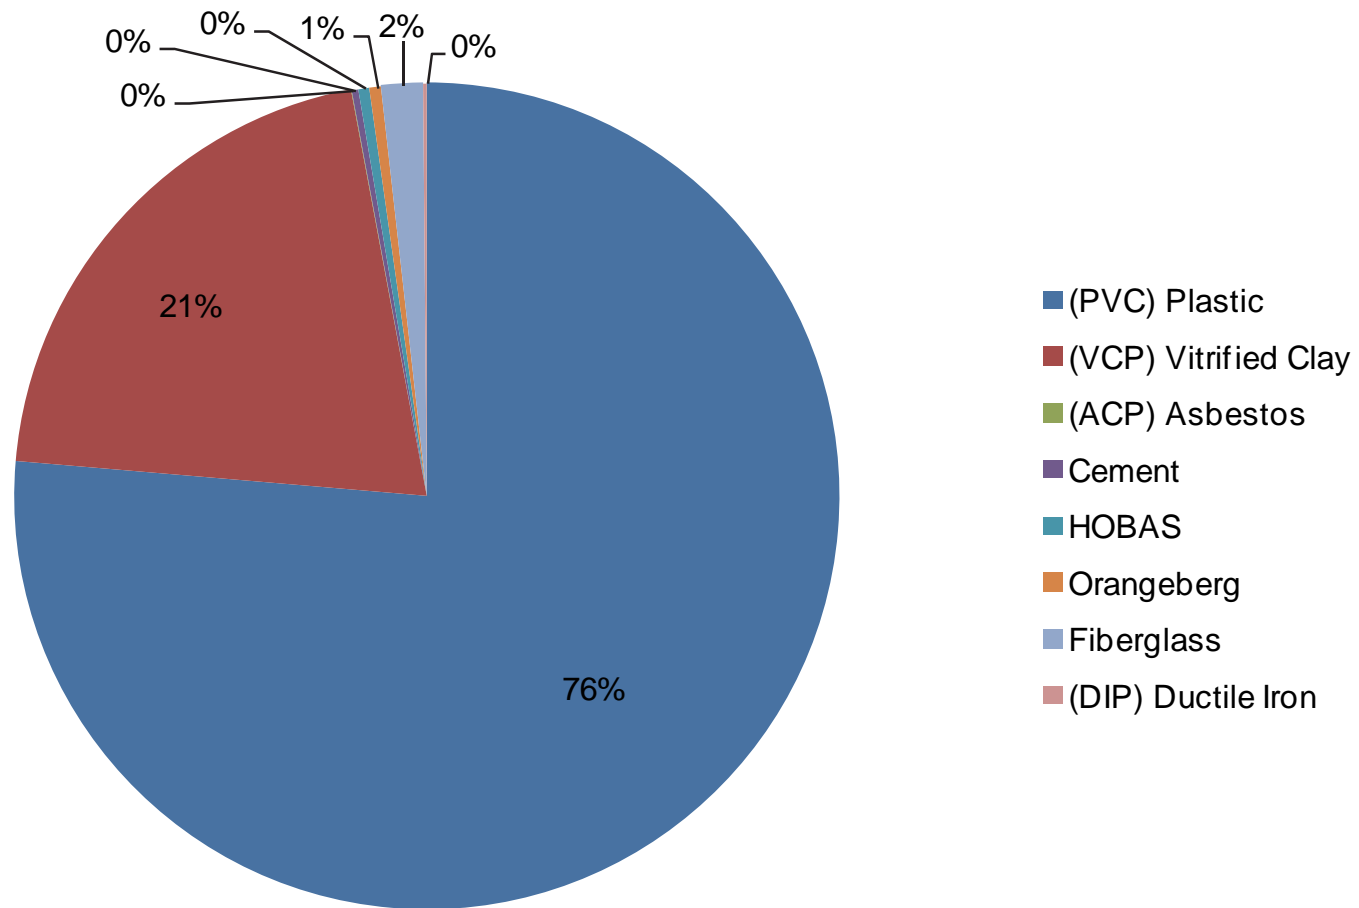
FIGURE 9

According to the GIS database, over 97 percent of the City's collection system pipe material is non-corrosion, being either polyvinyl chloride (PVC) or vitrified clay pipe (VCP). Based on pipe material alone, the vulnerability for failure due to corrosion is very low. Figure 9 illustrates the collection system pipe material types.

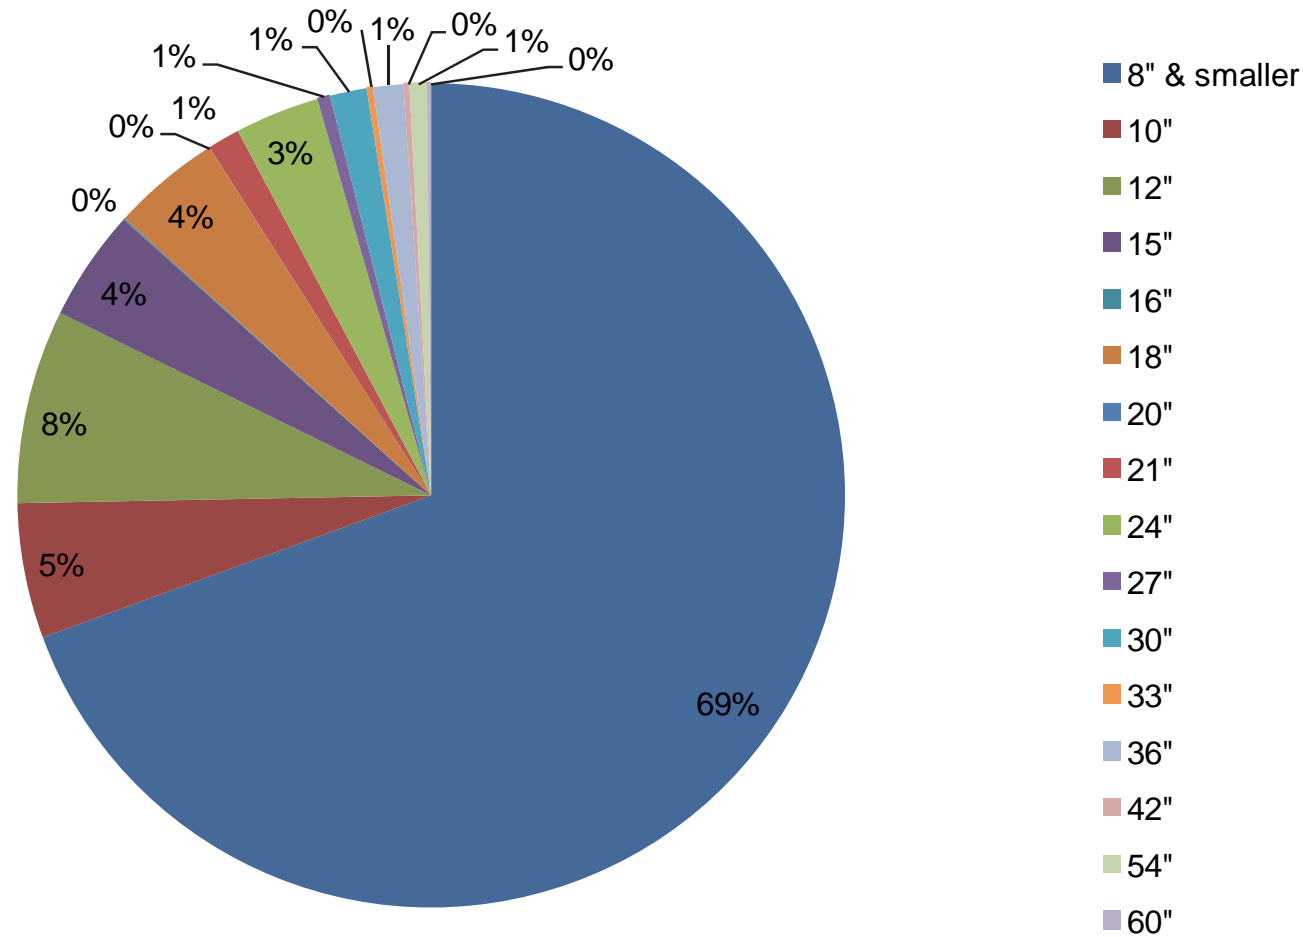
FIGURE 10

From the same GIS database, Carollo observed that 69 percent of the collection system is 8-inch in diameter or smaller. This suggests that overflow caused by debris or root intrusion is likely and that a CMOM program would be beneficial to the City. Figure 10 illustrates the collection system pipe diameters.

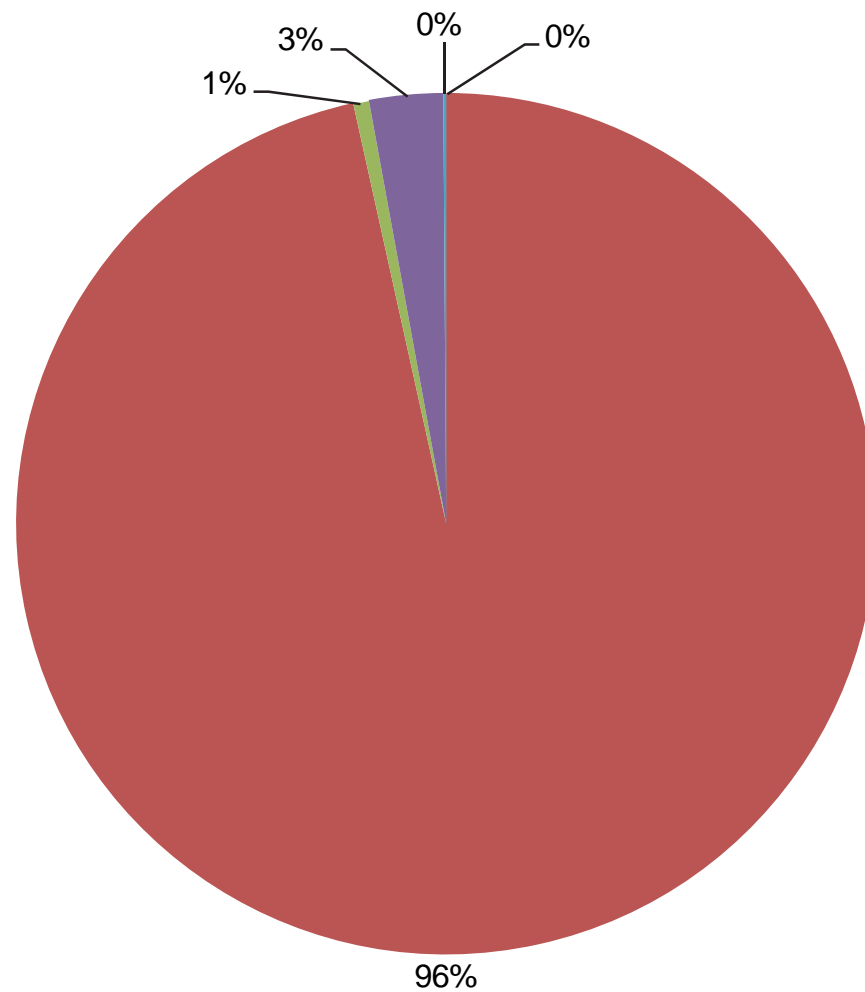
FIGURE 11

According to the GIS database, 96 percent of the water distribution system is ductile iron pipe (DIP). Figure 11 illustrates the water system pipe material types. Although DIP is a good choice from a durability point of view, from a corrosion standpoint, it can be susceptible to reduction in useful life if it was not properly protected during installation. From staff interviews, many pipes in south Goodyear were installed without plastic wrapping, and were installed in “hot soils.” The result for many pipes has been leaks and breaks, and likely more to come in the years ahead. Figure 12 illustrates the distribution of water pipe sizes over the approximate 1.9 million feet in the system. Over 65 percent is 8-inch or smaller in diameter indicating that they are distribution rather than transmission pipelines. Should the city proceed with field condition assessment of their liner water assets, we recommend they begin with the 35 percent of the pipelines since they represent the “backbone” of the water system.
