Wall Inspection Report

Inspection Date: May 21, 2020

Prepared for: Development Services
City of Goodyear
14455 W. Van Buren Street, Suite D101
Goodyear, Arizona, 85338

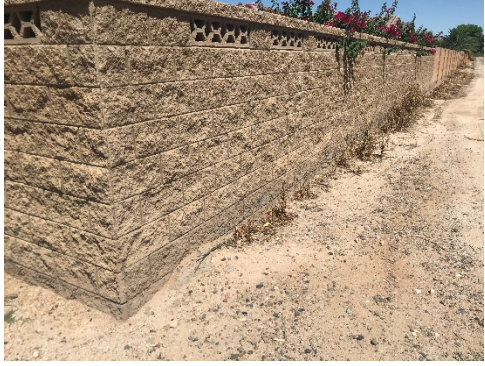
Figure 6. Split-face CMU

- **Concrete Masonry Unit (CMU)** refers to the blocks used in the wall construction. Two types of CMU's were observed along the wall. A thicker split-face type blocks was used for construction of the wall for two properties on the north end and one property on the south end of the wall (House numbers: 119, 133, and 385) shown in **Figure 6**. And standard 8" x 16" blocks were used for the rest of the wall shown in **Figure 7**.
